# CARDONE ProTech

## Battery Not Charging After Replacement of Chrysler PCM

1996-1998 Cherokee (XJ), Grand Cherokee (ZJ), Grand Cherokee (European Market) (ZG), Dakota (AN), Ram Truck (BR/BE), Ram Van (AB), Wrangler (TJ) and 1998 Durango (DN).

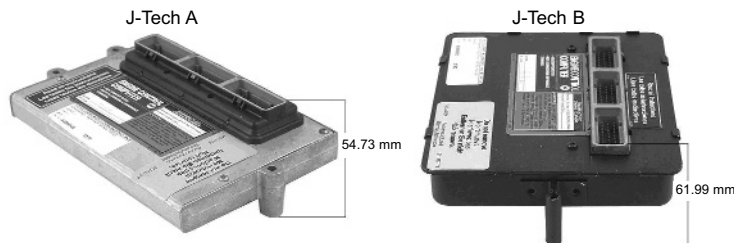
It has been found under certain "KEY ON" or momentary "KEY OFF" conditions, when the black connector is unplugged, the PCM may attempt to write information to the EEPROM processor within the PCM. Sometimes this inadvertent write will set the target charging voltage to 0 (Zero) volts. The result will prevent the charging system from charging the battery.

Whenever any connector on the PCM is disconnected, the ignition switch must be in the "off" position for a minimum of 5 seconds before connector removal.
