Bench Test for 2-Wire Window Lift Motors

Application All vehicles with electric windows (2-wire motor).

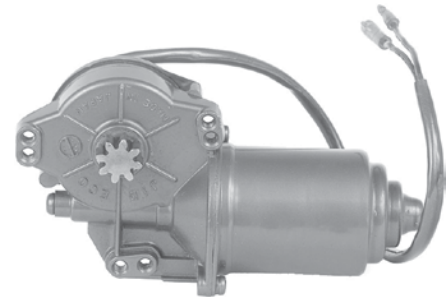
Problem Window lift motor replacement only operates in one direction.

Cause Possible faulty wiring or control switch.

Solution Most 2-wire window lift motors depend on a voltage polarity change to control direction. If the motor runs in one direction but not the other, the problem is in the vehicle wiring or switching. The test below can be used on 2-wire motors (typical unit shown).

Bench Test **Step 1:** Directly connect positive battery voltage to one motor wire and battery ground to the other motor wire. The motor should run in one direction.

Step 2: Reverse battery connections. The motor should now run in the opposite direction. If motor does not run, repeat test making sure connections and voltage source are good. After verifying proper motor operation, check the vehicle for these possible problems:

- Faulty switch circuitry or wiring
- Faulty or misadjusted window lift mechanism
- Refer to vehicle service manual for additional tests
