Failed Booster Seal Causes Master Cylinder Leaks

Application Vehicles equipped with power brake booster assemblies.

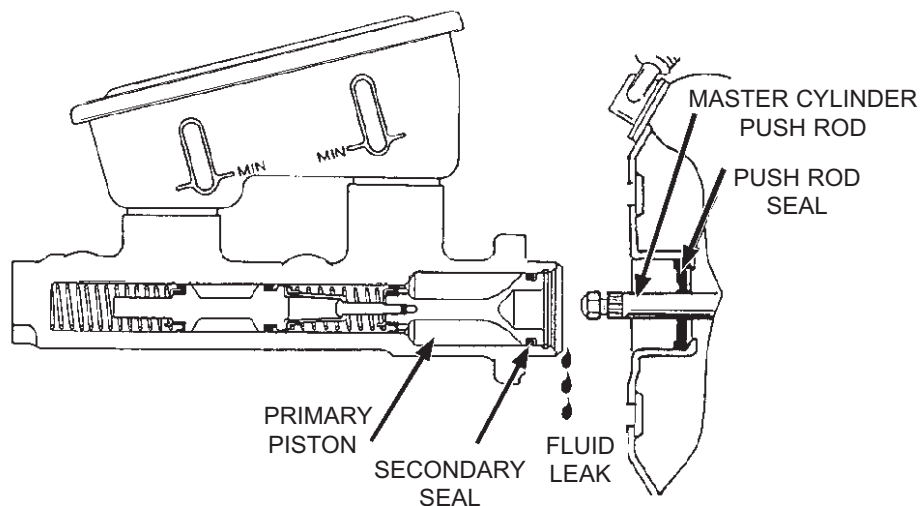
Problem Chronic master cylinder failure due to fluid leaking past secondary seal in the master cylinder bore.

Cause A defective master cylinder pushrod seal in the power brake booster allowing vacuum to draw fluid past secondary seal of the master cylinder.

Solution Replace both master cylinder and power brake unit.

Note When replacing brake components, always flush entire brake system with approved brake fluid from a sealed container.
