CARDONE™ ProTech®

Operating Wiper Motor Before Installation Causes Problems

Application All Electric Wiper Motors.

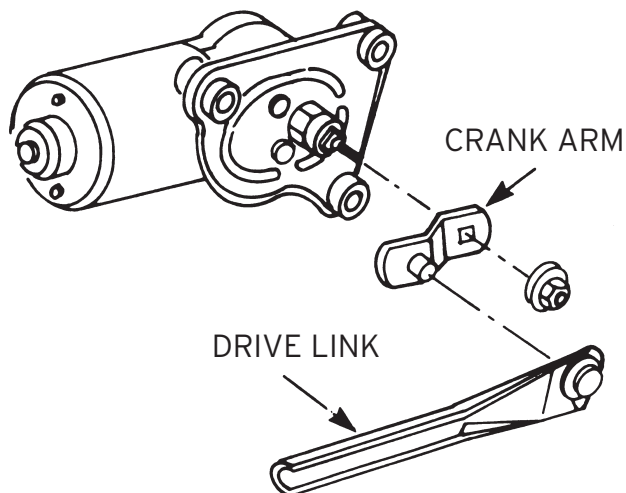
Problem Replacement wiper motor parks in wrong position.

Cause Power was applied to the unit before installation moving it off park position.

Solution Remove linkage from installed unit, operate motor on high speed for 5 seconds, then switch to park position. Reinstall linkage so wiper arms are in park position. Operate unit and test for proper operation. If not correct, test motor ground (see ProTech® PT 40-0001), also refer to vehicle service manual for specific installation procedures.

Note CARDONE units are supplied in the correct park position.
